# BruxZir Solid Zirconia

SIX-YEAR CLINICAL PERFORMANCE

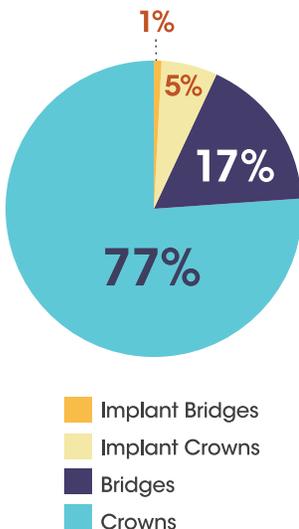
**Fig. 1:** Distribution of BruxZir Solid Zirconia restorations at placement.

A total of over 2450 *BruxZir Solid Zirconia* restorations have been placed and monitored over the past six and a half years. The restorations included single crowns, implant crowns and three-, four-, five- and six-unit bridges (Figure 1). The restorations were cemented with adhesive and self-adhesive resin cements.

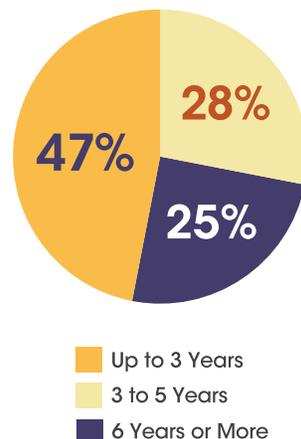
**Fig. 2:** Time in service for recalled BruxZir Solid Zirconia restorations.

1383 *BruxZir Solid Zirconia* were recalled out of 2450 total restorations placed. Among the recalled restorations 47% had been in function for up to three years, 28% up to five years and 25% up to six or more years (Figure 2). The majority of restorations (67%) were fabricated by Glidewell Laboratories, while the remaining restorations (33%) were fabricated by Apex Dental Milling. These restorations were evaluated in the following areas: esthetics, resistance to fracture/chipping, resistance to margin discoloration, wear resistance, and retention. They were rated on a scale of 1 to 5: 1 = poor, 2 = fair, 3 = good, 4 = very good, 5 = excellent.

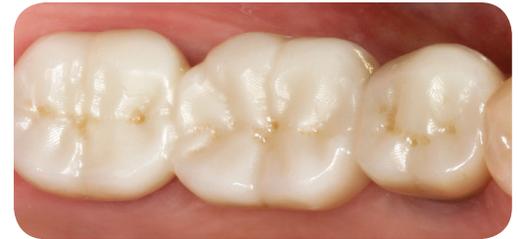
BruxZir #30

BruxZir Bridge #18-20

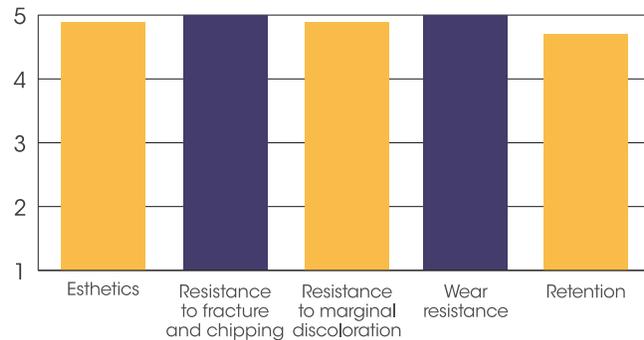
**Fig. 3:** Results of BruxZir Solid Zirconia restorations at six years.

The esthetics of *BruxZir Solid Zirconia* restorations was excellent (Figure 3). This rating is based on the uniformity and consistency of the shades in comparison to other monolithic zirconia restorations. *Zirconia restorations tend to be more opaque, but newer zirconias like BruxZir 16 and BruxZir Anterior definitely exhibit greater translucency.* Since many patients whiten their teeth, they actually like the opacity of zirconia.

Chipping and fracture of *BruxZir Solid Zirconia* restorations have been practically non-existent (Figure 3). Only five single crown fractures have been observed, mainly due to insufficient clearance after tooth preparation. Having less than 1 mm clearance is not recommended for posterior teeth. Two, five-unit bridges fractured and were replaced with PFM bridges. In both cases, the clearance was minimal and the patients were heavy bruxers. Sufficient clearance is especially important in longer span bridges. Two additional crowns fractured after root canal treatment. It is advisable to use round, fine grit diamond burs to make the access opening.

Only eight (0.5%) of the **BruxZir Solid Zirconia** restorations exhibited slight marginal discoloration at the six year recall (Figure 3). The opacity of the crowns helps camouflage most staining and microleakage to a certain extent. **Furthermore, microleakage is a function of the bonding agent and cement rather than the zirconia itself.**

Zirconia is a very wear resistant material and hardly any wear was observed on **BruxZir Solid Zirconia** crowns (Figure 3), while slight wear was observed on opposing enamel. More wear was noted on gold restorations when opposing zirconia crowns.

Ninety (3.7%) out of 2450 **BruxZir Solid Zirconia** restorations debonded and required re-cementation over the six-year recall period (Figure 3). This debonding rate is slightly higher when compared to non-zirconia crowns (2%) that DENTAL ADVISOR has documented over more than 20 years. It is advisable to prime zirconia crowns prior to cementation to improve retention. In fact, DENTAL ADVISOR observed that when primed, debonded crowns retained the cement on the internal surface of the crown but not on the tooth itself.
